## REVERSED CYCLIC IN-PLANE TESTS OF LOAD-BEARING PLASTERED STRAW BALE WALLS

### SUMMARY

The results of an experimental study on the lateral load resisting characteristics of 6 full-scale straw bale wall assemblies are presented. Walls having earth plaster and cement stucco skins and varied levels of detailing were subjected to reversed cyclic lateral loads. Preliminary recommendations are made for wall detailing, allowable design strengths, and R factors that may be used for seismic design, for walls that are nominally 8 ft. high by 8 ft long.

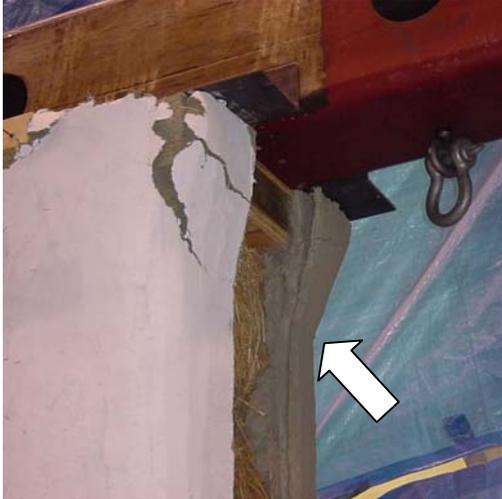
(a) Slip of the box beam at the top of Wall A

- Wall A had a peak strength of 3.2 kips (400 plf), which was reached at 4% drift (3.84 inches) and was maintained for higher displacements. The lack of mesh to anchor the earth plaster to the header beam led to slip of the header beam relative to the top course of bales Figure 9a. For drifts less than 2.5%, the failure mode appeared to be dominated by this slip. At drifts greater than 2.5%, crushing of the earth plaster in the compression zone began as the lateral resistance increased to its maximum of 3.2 kips. This change in behavior suggests that the poly-twine loops became engaged after the box beam slipped sufficiently. There was no evidence to suggest the poly-twine failed at any point during the tests, as the poly-twine was found to be taught when inspected at the gaps that opened at the base of the wall during testing.

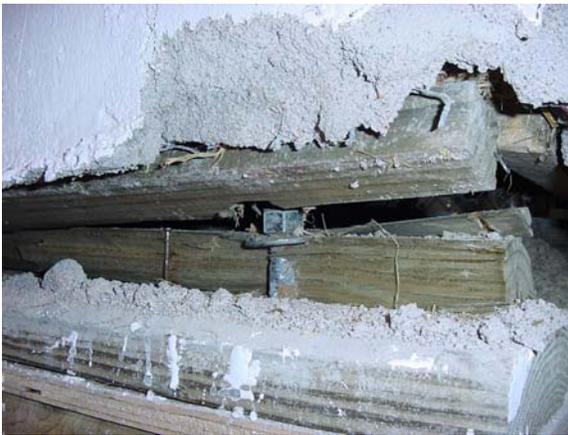
(c) Cross grain tension failure of 2 x 4 sill at base of Wall D (5% drift)

two distinct failure modes were observed at the base of the wall. In some locations the chicken wire mesh was distorted and elongated, and had fractured, while at other locations the  $2 \times 4$  sill plate receiving the mesh staples had failed in cross-grain bending as shown in Figure 9c. By the end of the test, the combination of mesh fractures and sill failure had progressed along the full length of the wall, allowing the observed rocking behavior to occur unimpeded. None of the staples anchoring the mesh were observed to fail or pull out.
